Insula spa  
Company for urban maintenance in Venice  
info@insula.it – 041 2724354 – 041 2724244 fax

# Venice

## Preservation and urban maintenance

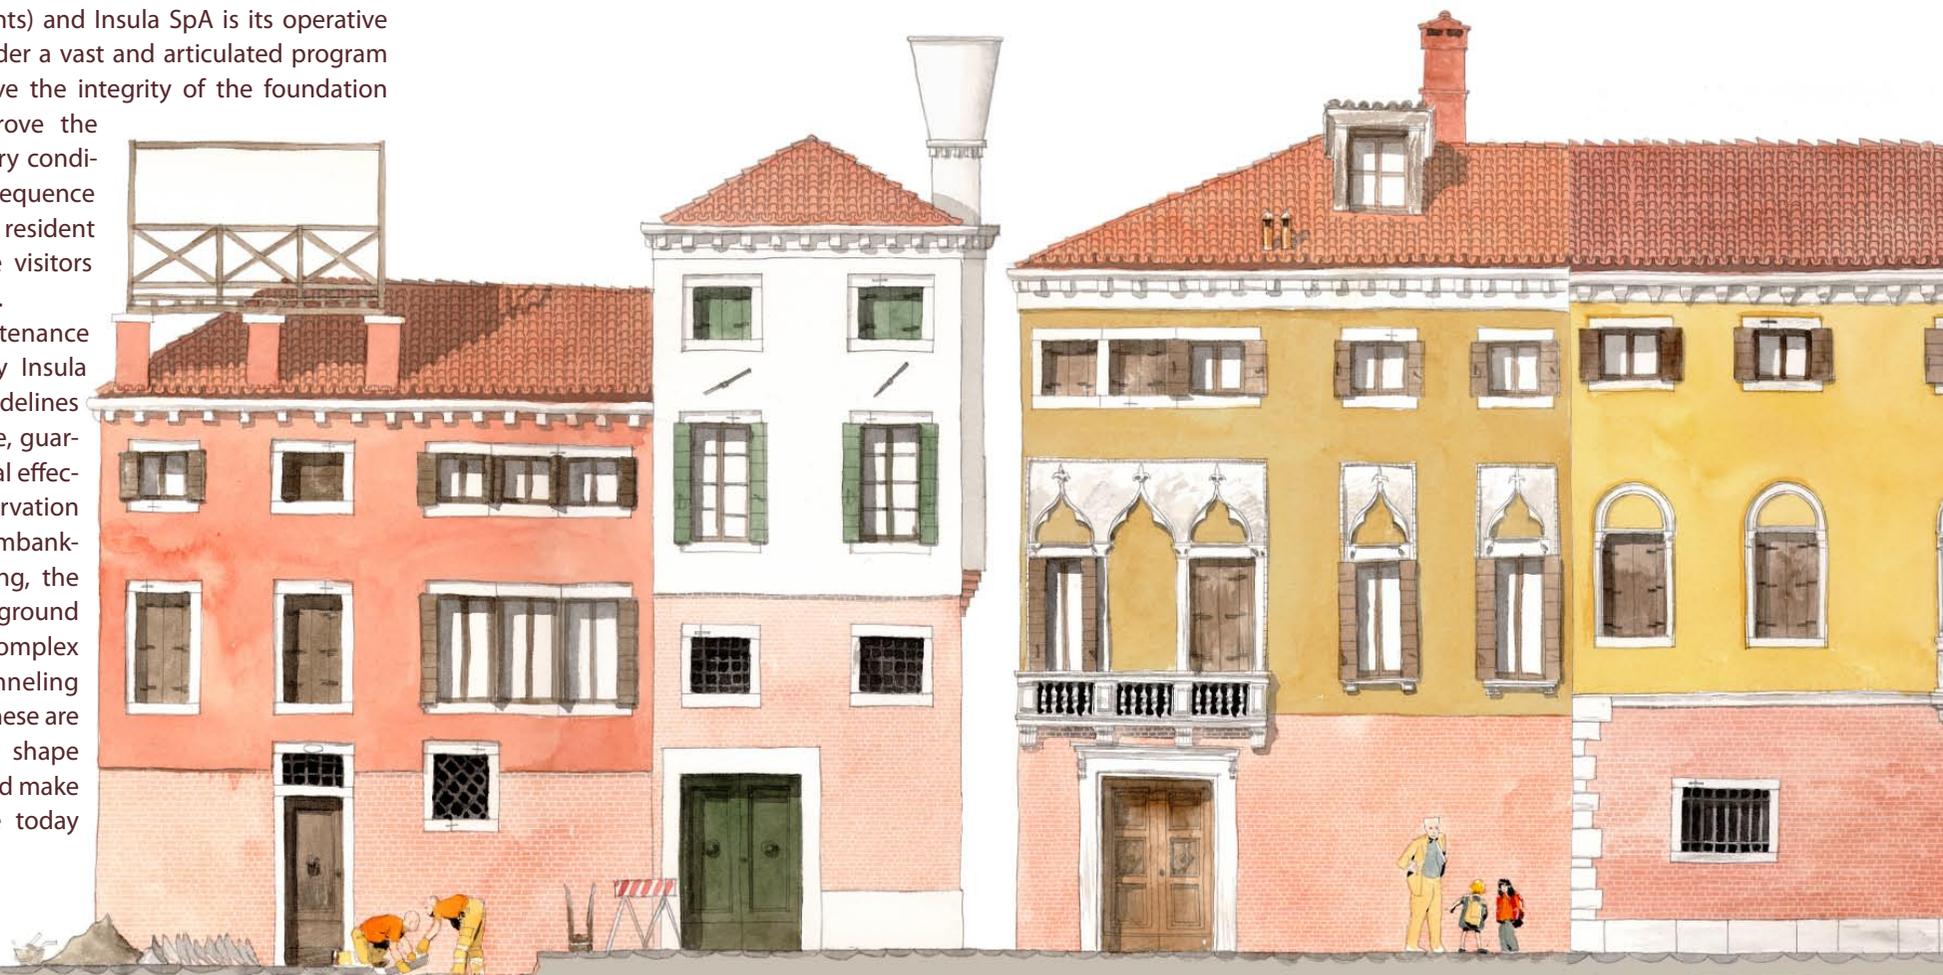
The plan to raise the paving in the city primarily concerns the lowest areas (the ones that are more prone to flooding even when the tide is not particularly high) to build to a level, where possible, of +120 cm. During construction, architectural and environmental constraints are respected, seeking as far as possible to maintain the original appearance of the walls and the level of the entrances to homes and public spaces.

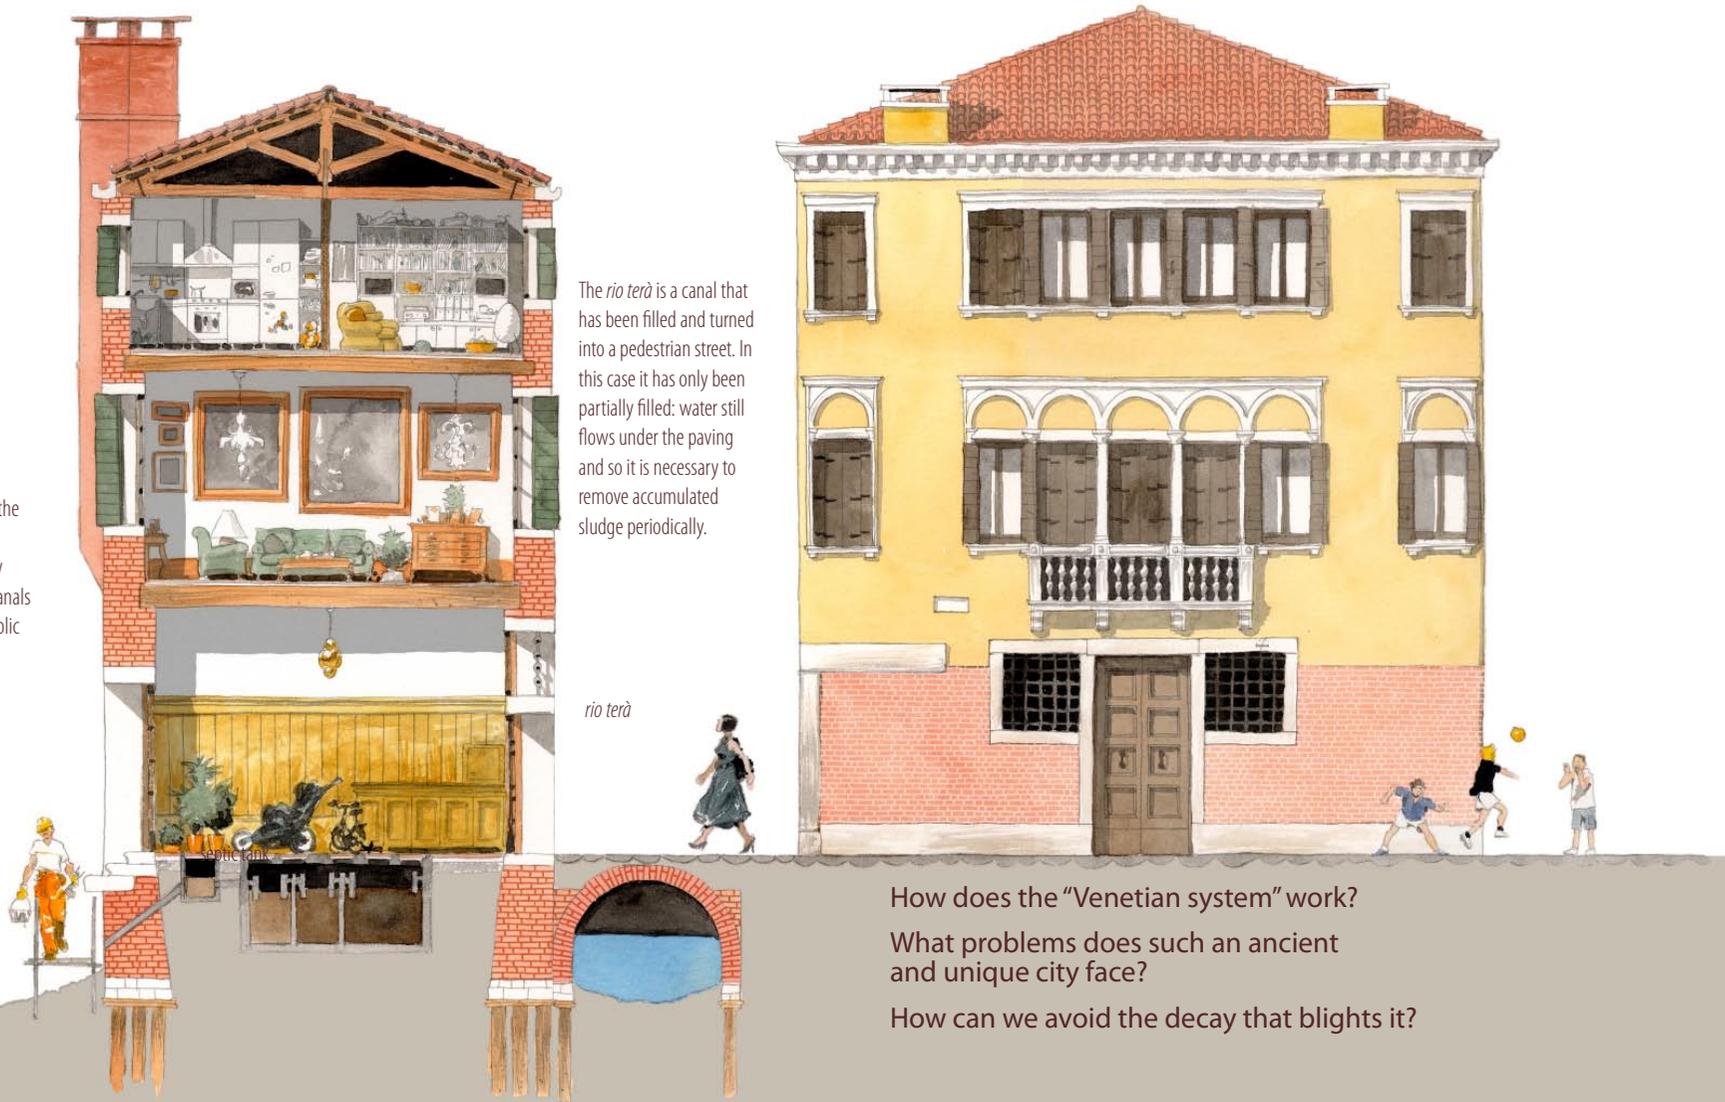
A *rio terà* may be totally filled (in this case there is no more circulation on the water) or partially filled (in this case a channel remains open under the paving). In the latter case, it is important to periodically dredge the channels of the sludge and sediment that accumulates to prevent it from becoming obstructed.

To do so, in many cases a new non-invasive avant-garde methodology is used: an opening in the vault of the underground channel allows special machines to activate a pump that sucks up the sludge into a tank. The sludge is then conveyed through waterproof hoses into a boat and taken to an authorized dumping site.

The *rio terà* is a canal that has been filled and turned into a pedestrian street. In this case it has only been partially filled: water still flows under the paving and so it is necessary to remove accumulated sludge periodically.

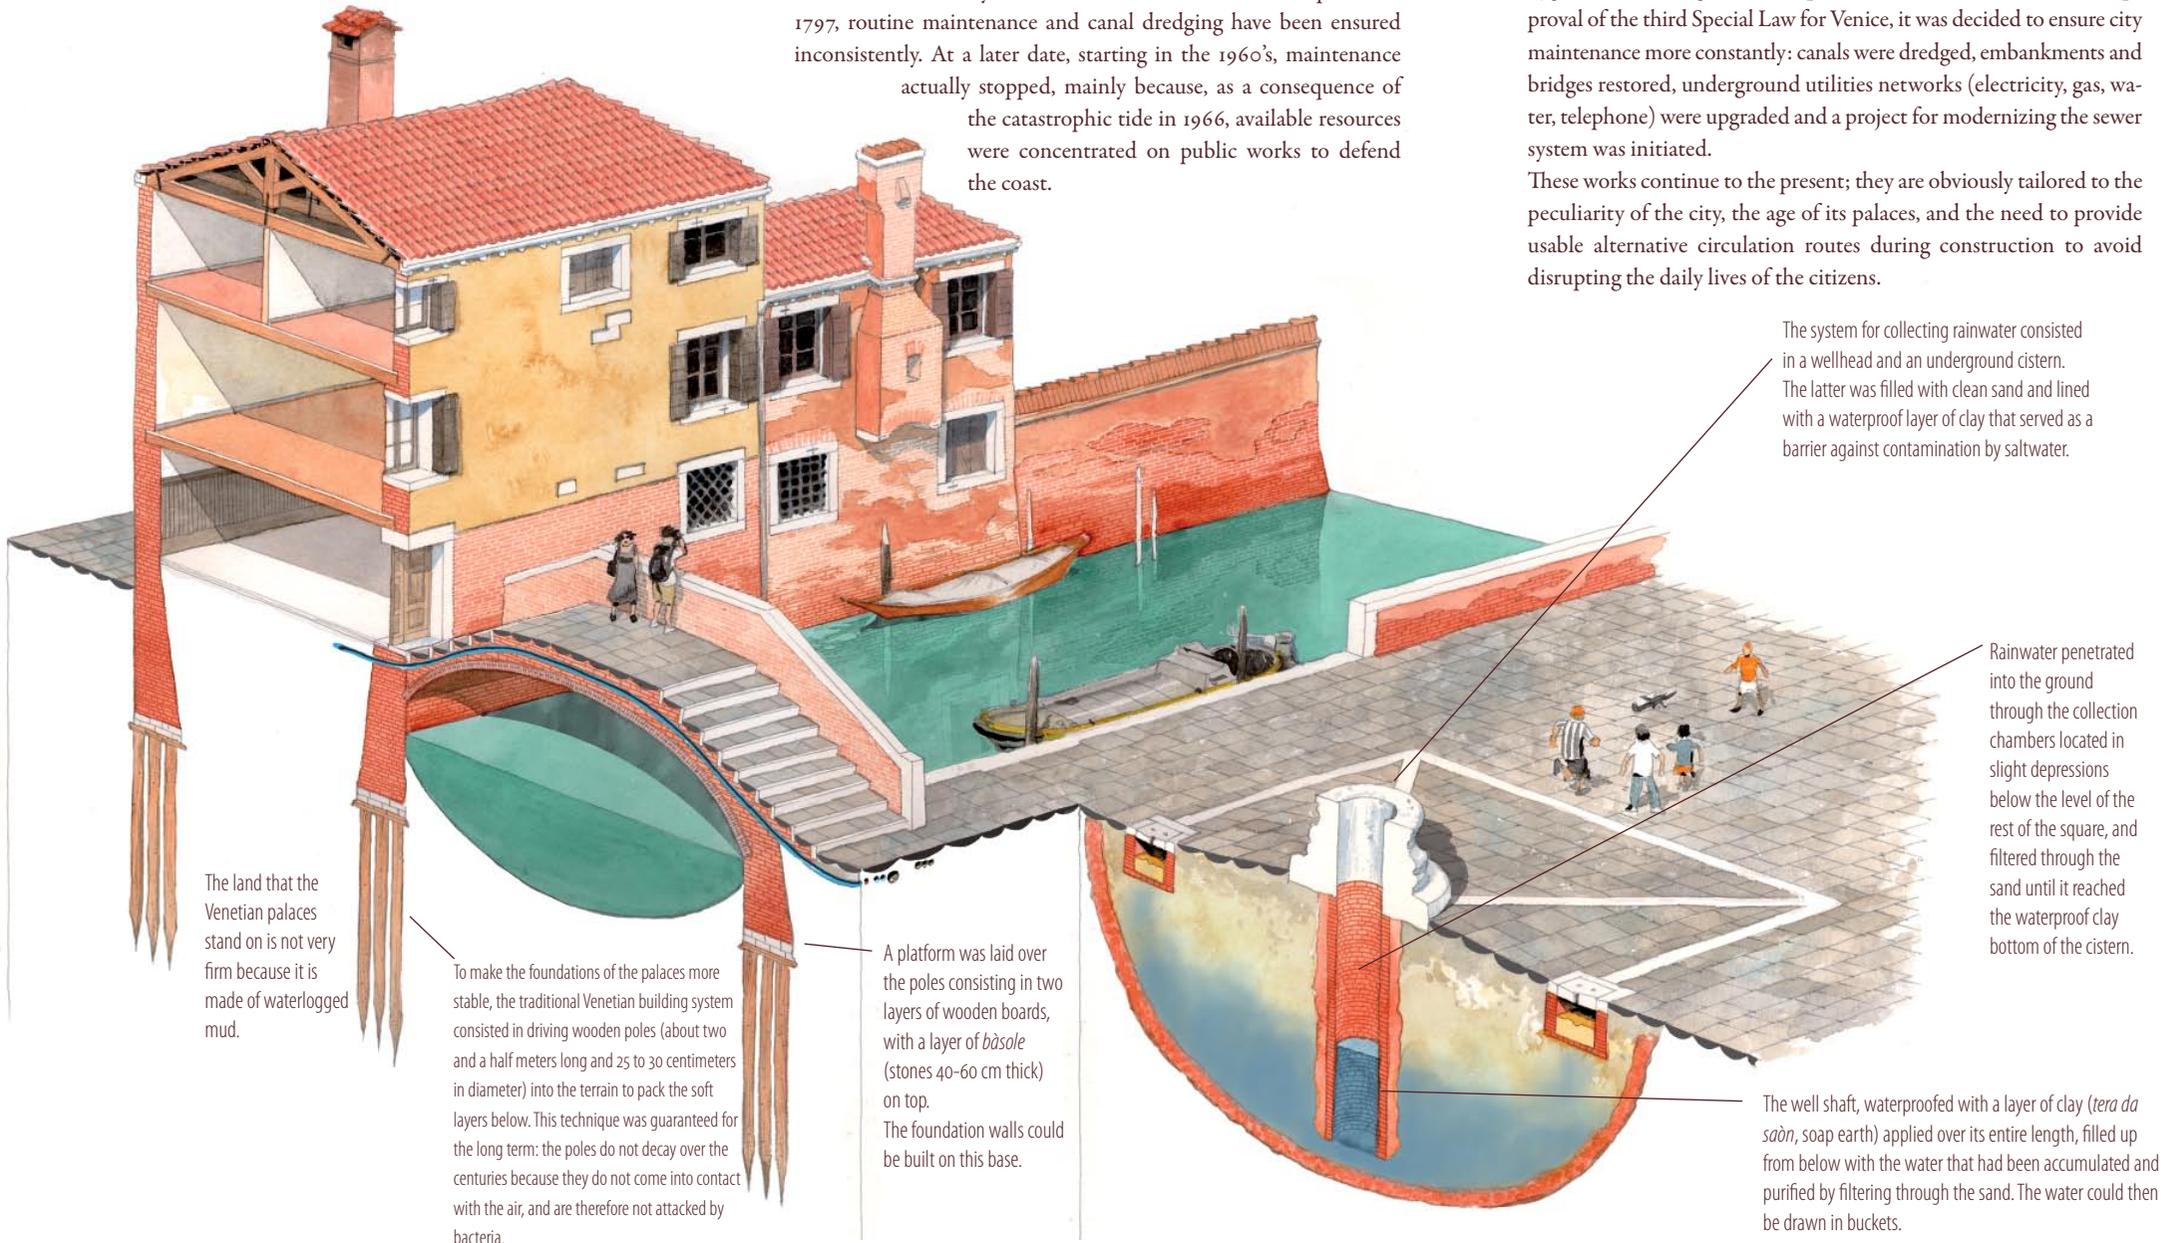
The land that the Venetian palaces stand on is not very firm because it is made of waterlogged mud.

To make the foundations of the palaces more stable, the traditional Venetian building system consisted in driving wooden poles (about two and a half meters long and 25 to 30 centimeters in diameter) into the terrain to pack the soft layers below. This technique was guaranteed for the long term: the poles do not decay over the centuries because they do not come into contact with the air, and are therefore not attacked by bacteria.

A platform was laid over the poles consisting in two layers of wooden boards, with a layer of *bàsole* (stones 40-60 cm thick) on top. The foundation walls could be built on this base.

The system for collecting rainwater consisted in a wellhead and an underground cistern. The latter was filled with clean sand and lined with a waterproof layer of clay that served as a barrier against contamination by saltwater.

Rainwater penetrated into the ground through the collection chambers located in slight depressions below the level of the rest of the square, and filtered through the sand until it reached the waterproof clay bottom of the cistern.

The well shaft, waterproofed with a layer of clay (*tera da saòn*, soap earth) applied over its entire length, filled up from below with the water that had been accumulated and purified by filtering through the sand. The water could then be drawn in buckets.

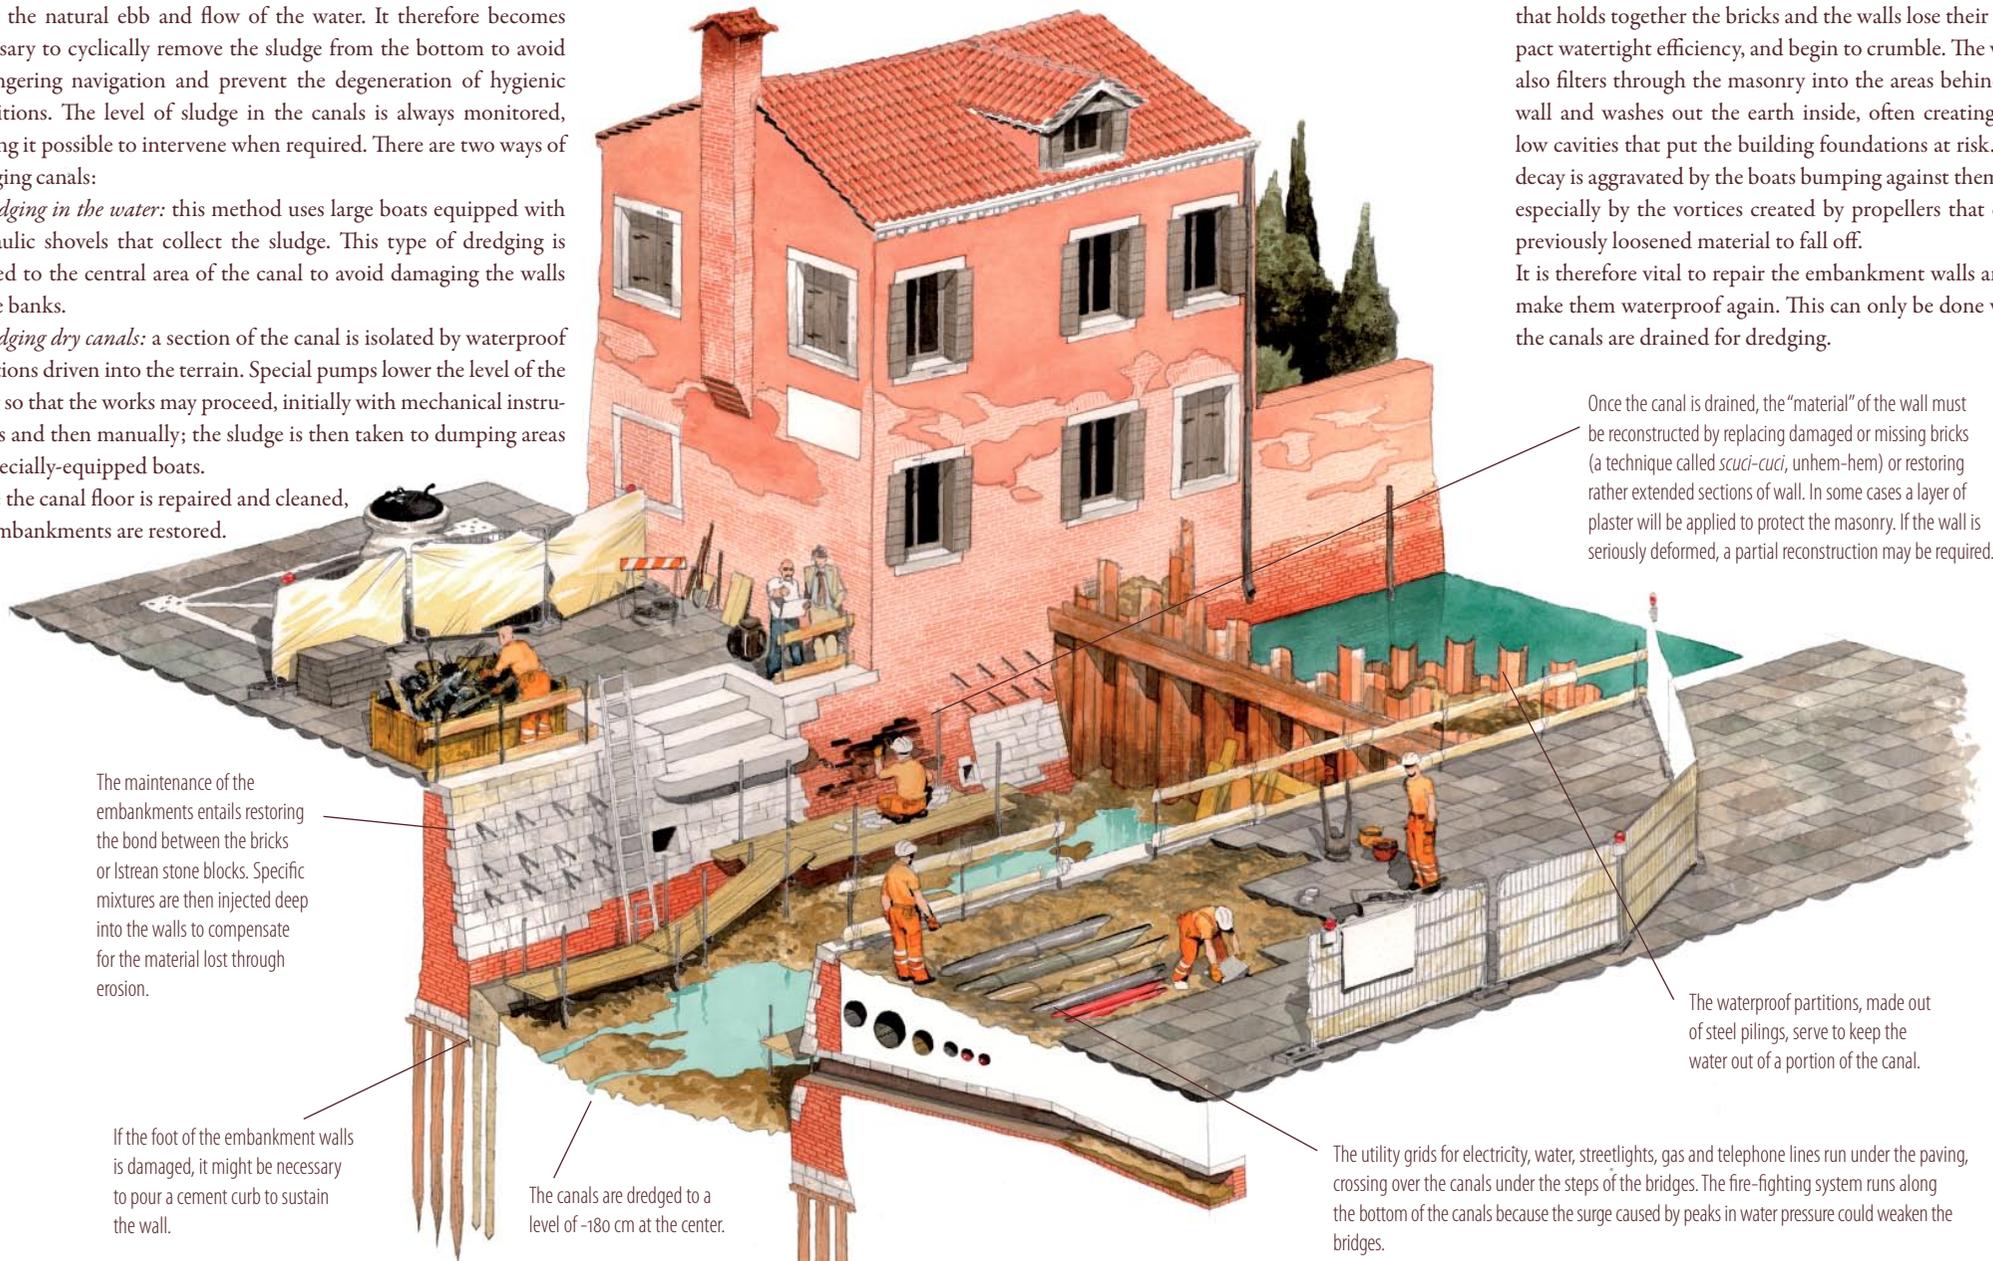
The maintenance of the embankments entails restoring the bond between the bricks or Istrian stone blocks. Specific mixtures are then injected deep into the walls to compensate for the material lost through erosion.

If the foot of the embankment walls is damaged, it might be necessary to pour a cement curb to sustain the wall.

The canals are dredged to a level of -180 cm at the center.

The utility grids for electricity, water, streetlights, gas and telephone lines run under the paving, crossing over the canals under the steps of the bridges. The fire-fighting system runs along the bottom of the canals because the surge caused by peaks in water pressure could weaken the bridges.

The waterproof partitions, made out of steel pilings, serve to keep the water out of a portion of the canal.
